MITIGATION PLAN FOR THE COVE SPRING STREAM RESTORATION PROJECT FRANKLIN COUNTY, KENTUCKY

September 10, 2009

Mitigation Plan for the Cove Spring Restoration Project

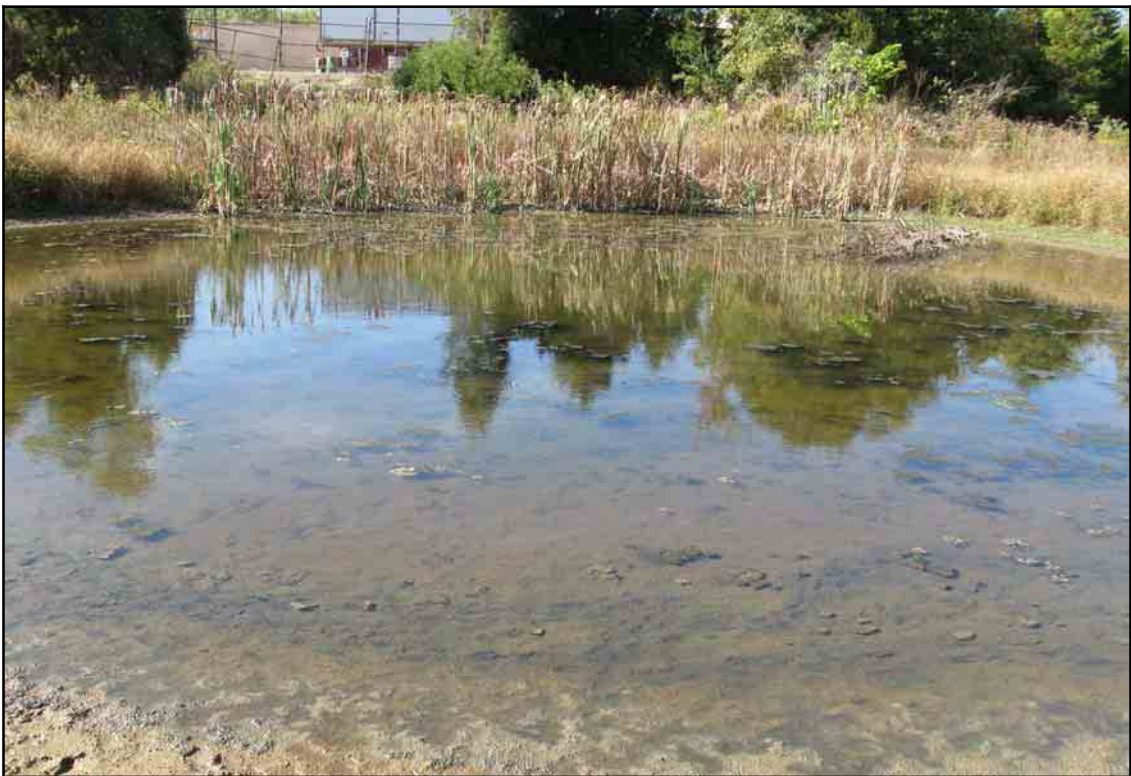
Open water 2 (OW-2) facing south.

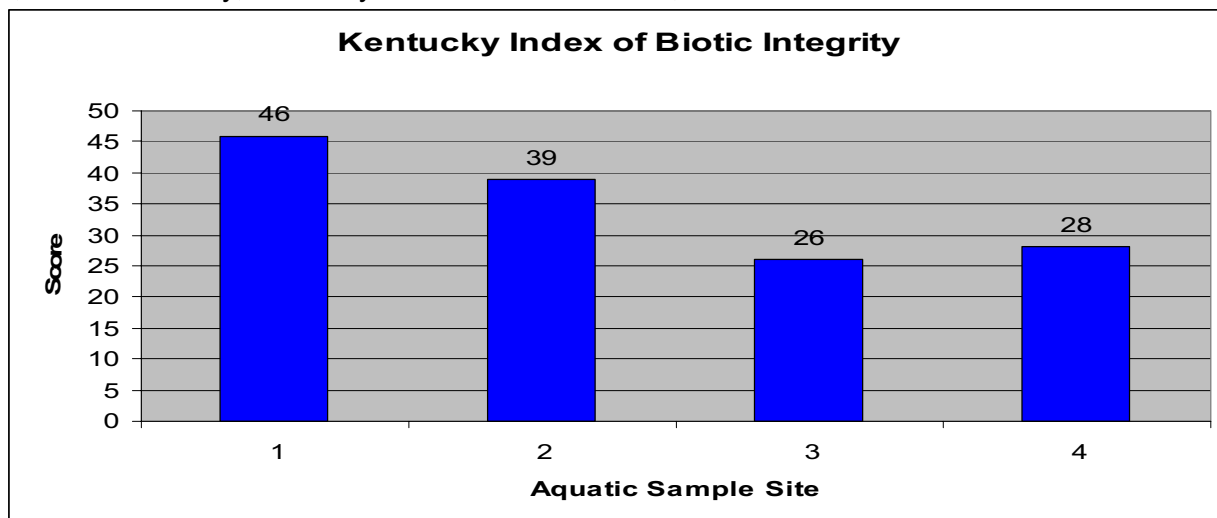
Figure 1. KIBI values for the Cove Spring stream restoration project aquatic sample sites AS1-4, Franklin County, Kentucky. Data collected June 4, 2008

Orangethroat darters (*Etheostoma spectabile*; n=29) were the most numerous species captured, followed by fantail darters (*Etheostoma flabellare*; n=15) and creek chubs (*Semotilus atromaculatus*; n=11). Overall, these fish were more abundant than any other fish species captured. Other species collected include green sunfish (*Lepomis cyanellus*), banded sculpin (*Cottus carolinae*), bluntnose minnow (*Pimphales notatus*), rainbow darter (*Etheostoma caeruleum*), western mosquitofish (*Gambusia affinis*), bluegill (*Lepomis macrochirus*), longear sunfish (*Lepomis megalotis*), and central stoneroller (*Camptostoma anomalum*).

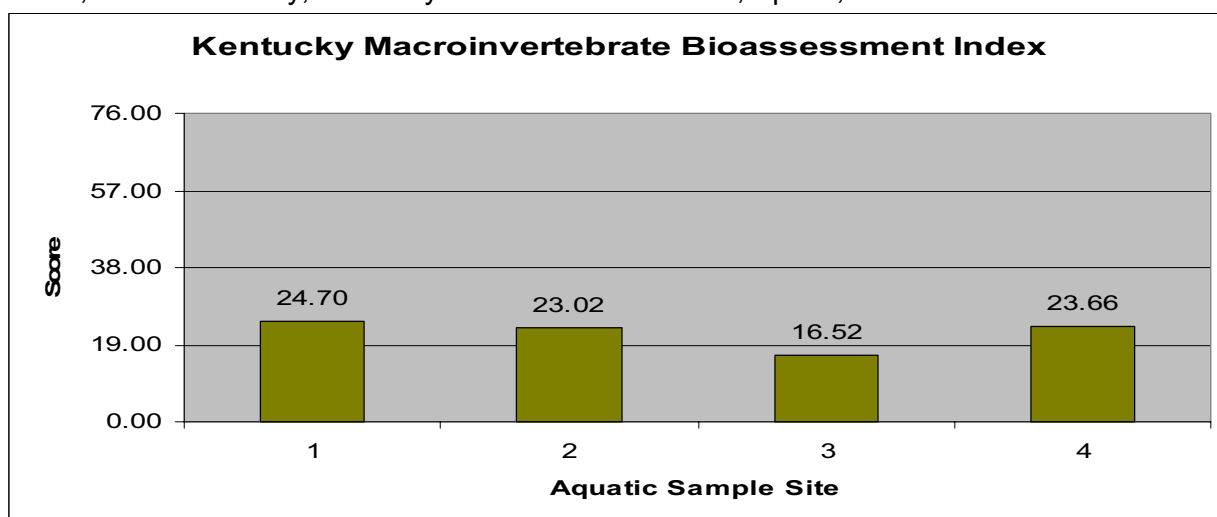
Figure 2. KMBI values for the Cove Spring stream restoration project aquatic sample sites AS1-4, Franklin County, Kentucky. Data collected June 4, April 2, 2008.

ETC ecologists sampled the macroinvertebrate communities at four sample sites (AS-1-4) along the main stem of Penitentiary Branch within the Cove Spring stream restoration area. Sample results and calculated KMBI values for macroinvertebrates are found in Appendix A-Table 2 and summarized in Figure 2. A total of 798 macroinvertebrates representing 22 families and 23 taxa were collected and identified from both the semi-quantitative (riffle) and qualitative (multi-habitat) samples. Taxa richness (genus level) was similar among the four sites, ranging from 10 (AS-1&2) to 16 (AS-4). AS-1 contained the highest number of individuals collected (262 total), approximately 65% of which was comprised of four generally pollution tolerant groups (Crangonyctidae, Oligochaeta, Chironomidae, Asellidae). Isopods were, by far, the most commonly encountered invertebrate from all sites. Three sites scored in the “poor” category for calculated KMBIs, and one scored “very poor”. AS-3 had the lowest KMBI score (16.52), and AS-1 had the highest at 24.7.

The KMBI score is heavily weighted towards quality and taxonomic variability of the quantitative riffle sample. Riffle organisms from the orders Ephemeroptera (mayflies), Plecoptera (stoneflies), and Trichoptera (caddisflies) also receive special attention as they have shown to be sensitive to a variety environmental cues. For Penitentiary Branch, all riffle organisms, with the exception of Isopods, continue to be depauperate. Several factors, such as elevated sedimentation, poor substrate sorting, low dissolved oxygen, and chemical contaminants, may contribute to the observed results. However, significant development of riffle invertebrate assemblages should not be expected here even under ideal circumstances, because much of the stream bed goes dry in the warmer months. This restricts the success of organisms that require multiple years (semivoltine) to complete their larval life stages. Isopods thrive, however, because they have the ability to follow receding water levels below the substrate to groundwater reservoirs and fulfill their biological demands.

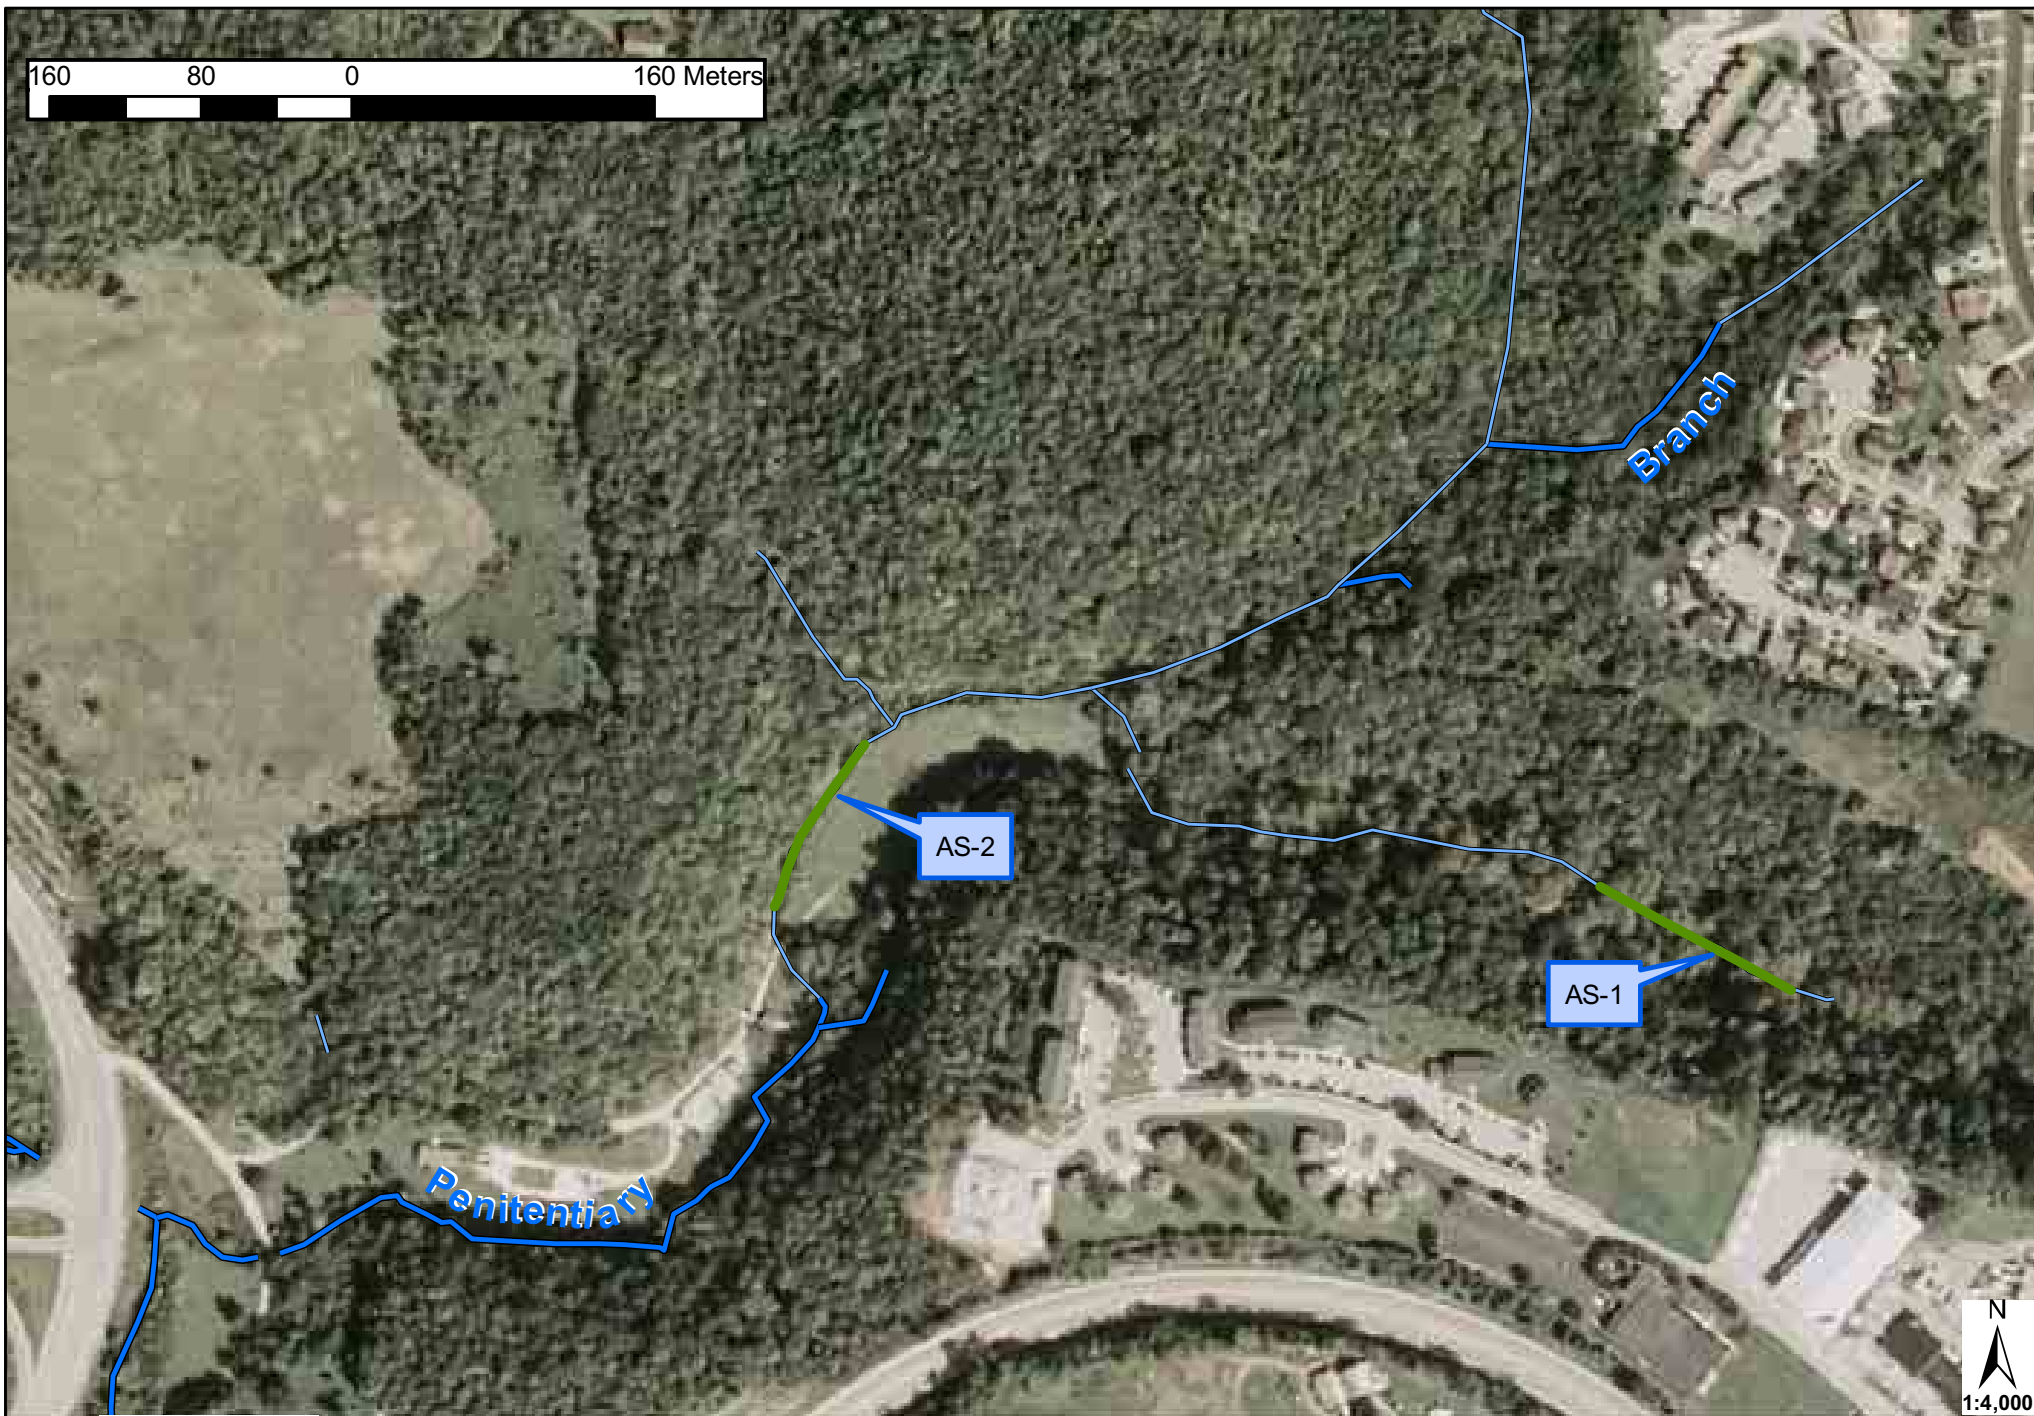
Aquatic Sample Sites
Baseline Aquatic Bioassessment Report
for the Cove Springs Stream Restoration Project,
Franklin County, Kentucky
FSA 2004 NAIP DOQQ

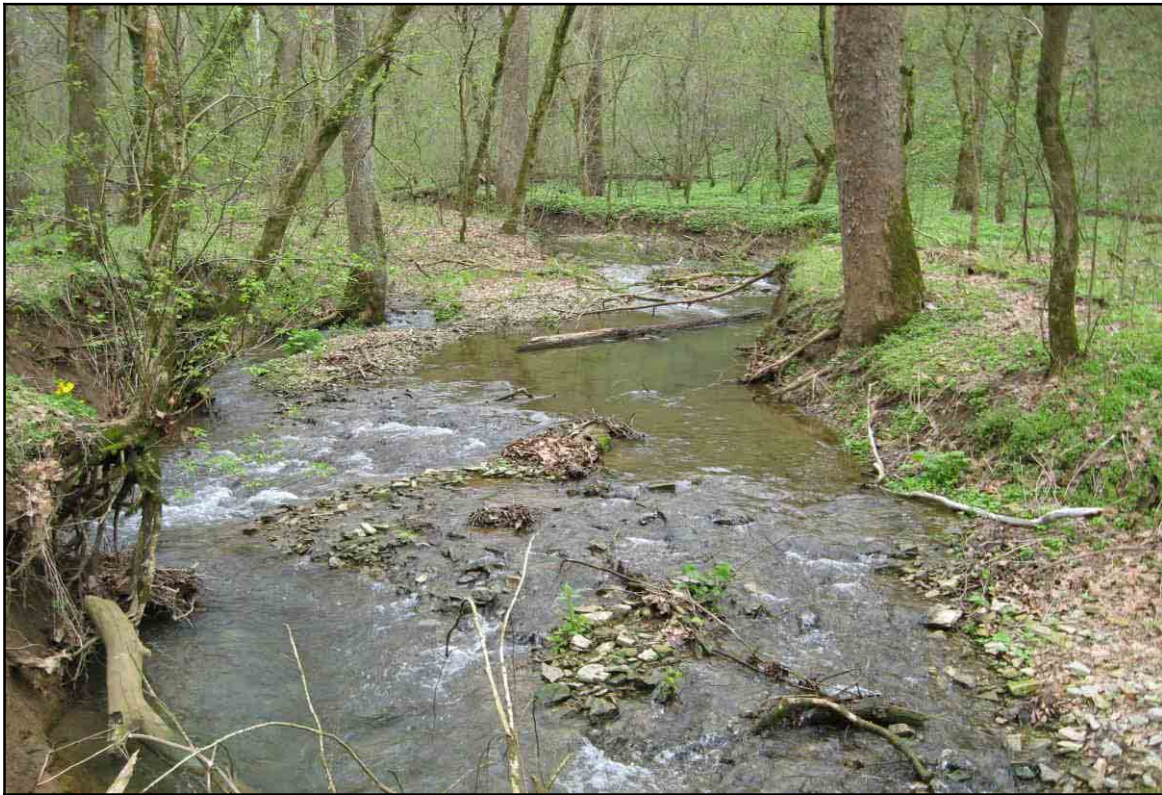
AS-1: Looking upstream (east; 2009)

Aquatic Sample Site 1 (AS-1) is located east of Cove Springs Park, upstream along Penitentiary Branch. At the time of study, weather conditions were sunny and clear. Temperature was approximately 70°F. During the previous 24 hours, there was no substantial rainfall. The surrounding landscape use is upland forest with some residential and industrial buildings along the ridge tops. The riparian zone was dominated by trees, shrubs, and forb species, (box elder [*Acer negundo*], green ash [*Fraxinus pennsylvanica*], spicebush [*Lindera benzoin*] and dogwood species [*Cornus* spp.]). The stream channel was approximately 3 meters wide and ranged from 1 to 18 inches in depth. The sample reach length was approximately 100 m in length with the substrate dominated by cobble and gravel in the riffles and sand/silt in the pools.

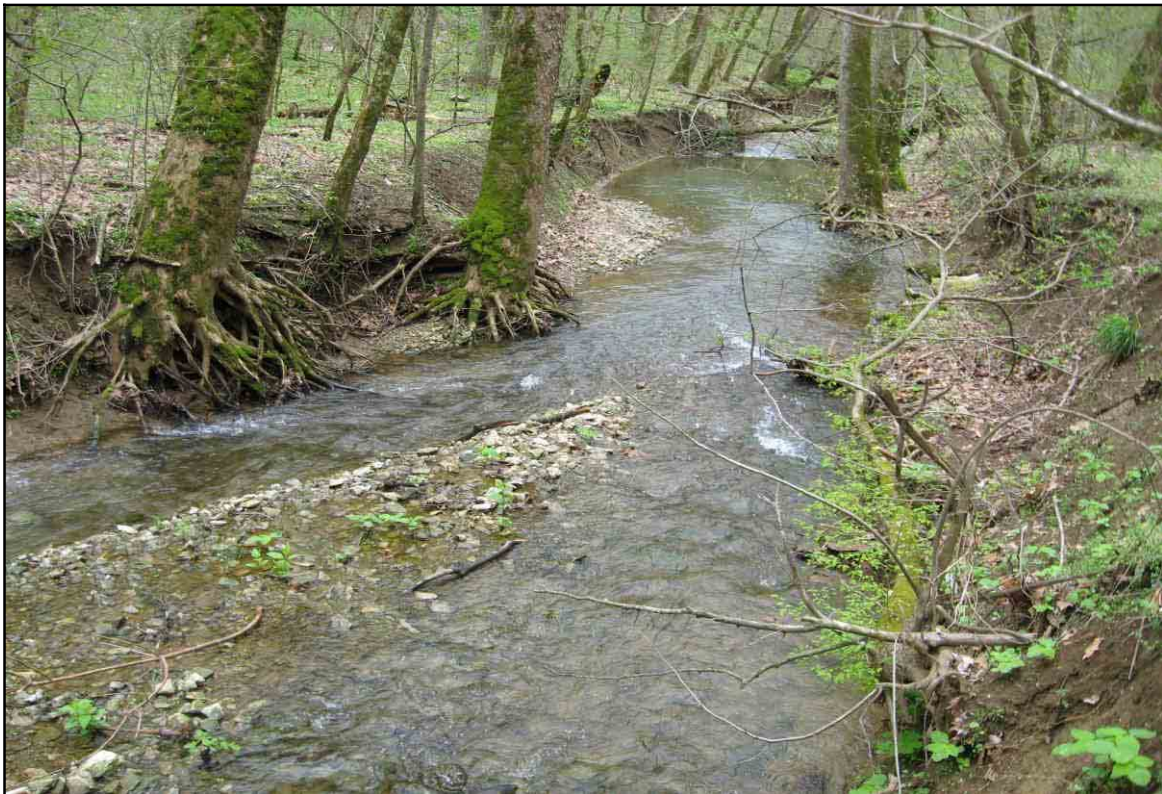
AS-1: Looking downstream (west; 2009)

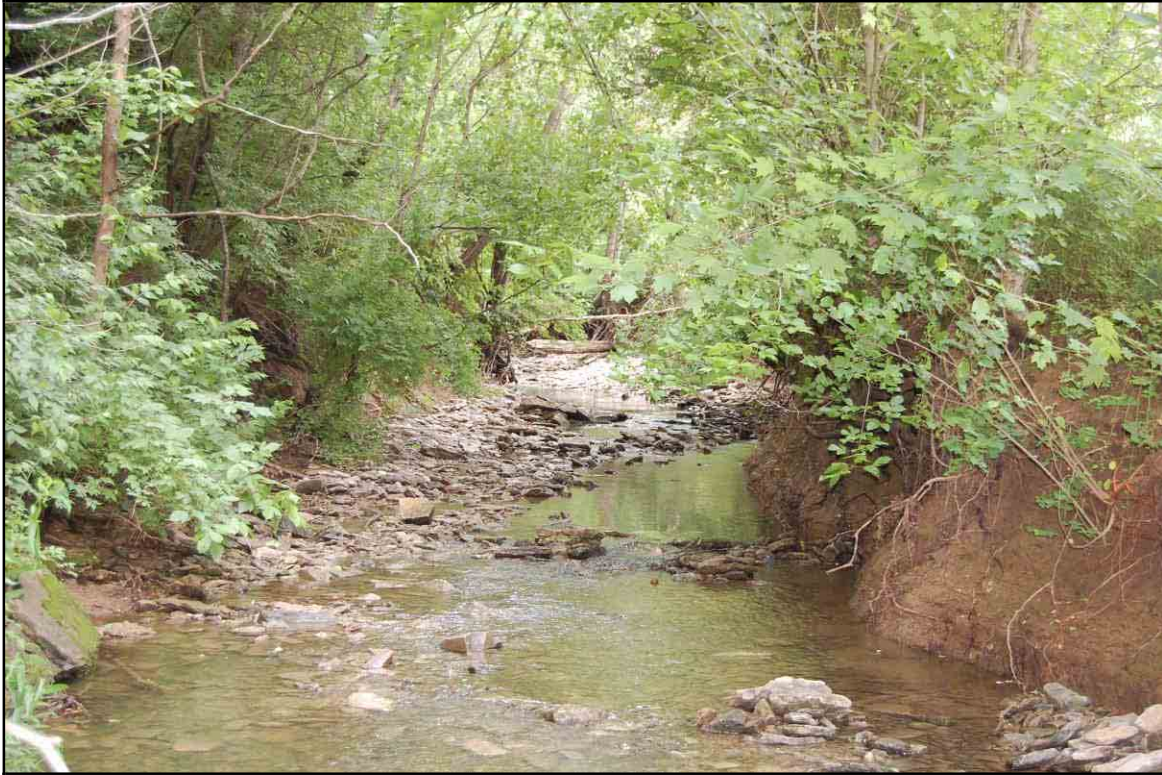
AS-2: Looking upstream (east; 2008)

AS-2 is located east of the main entrance to Cove Springs Park, upstream along Penitentiary Branch. At the time of study, weather conditions were sunny and clear. Temperature was approximately 80°F. During the previous 24 hours, there was no substantial rainfall. The surrounding landscape use is residential with some industrial. The riparian zone is comprised of upland forest on the right bank and open field on the left bank. Dominate tree and shrub species present are box elder, American sycamore (*Platanus occidentalis*), spicebush, and wild hydrangea (*Hydrangea arborescens*). The stream channel ranges 3-5 meters wide and 0 to 2 inches in depth. The reach length was approximately 100 m and possessed some evidence of channelization. The streambed at this site is dominated by cobble/bedrock in the riffles and sand/silt in all other habitats.

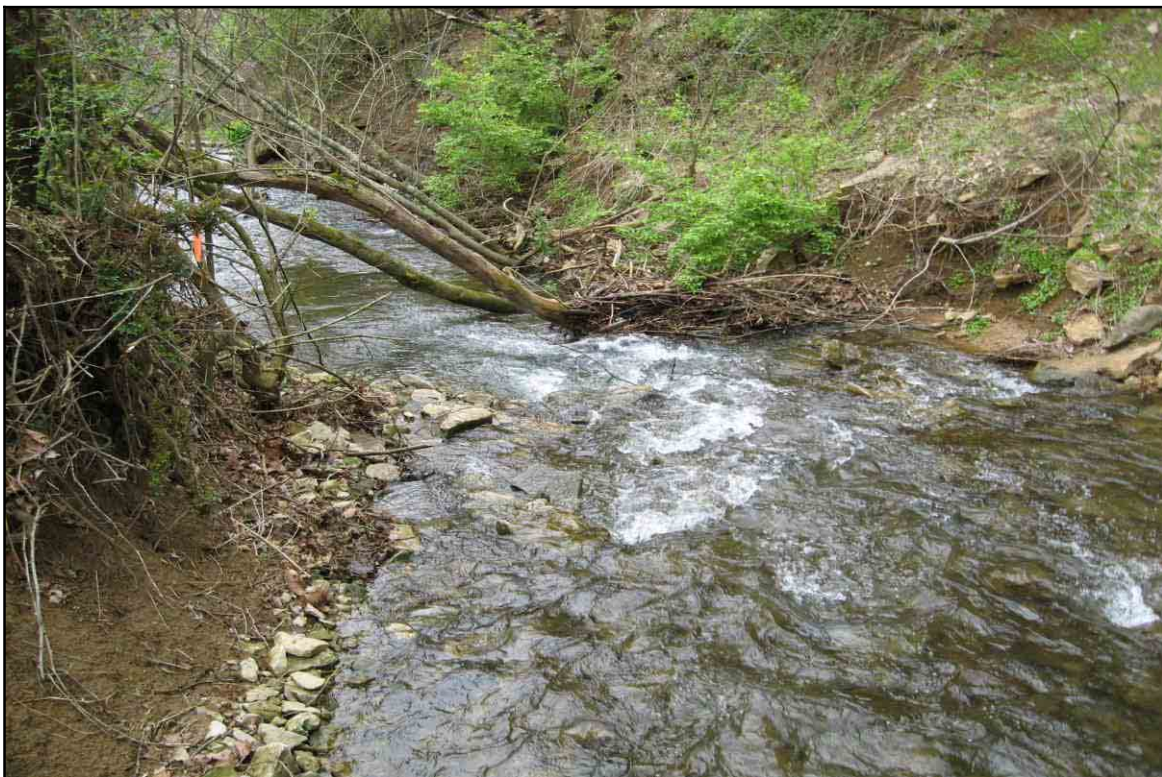
AS-2: Looking downstream (west; 2009)

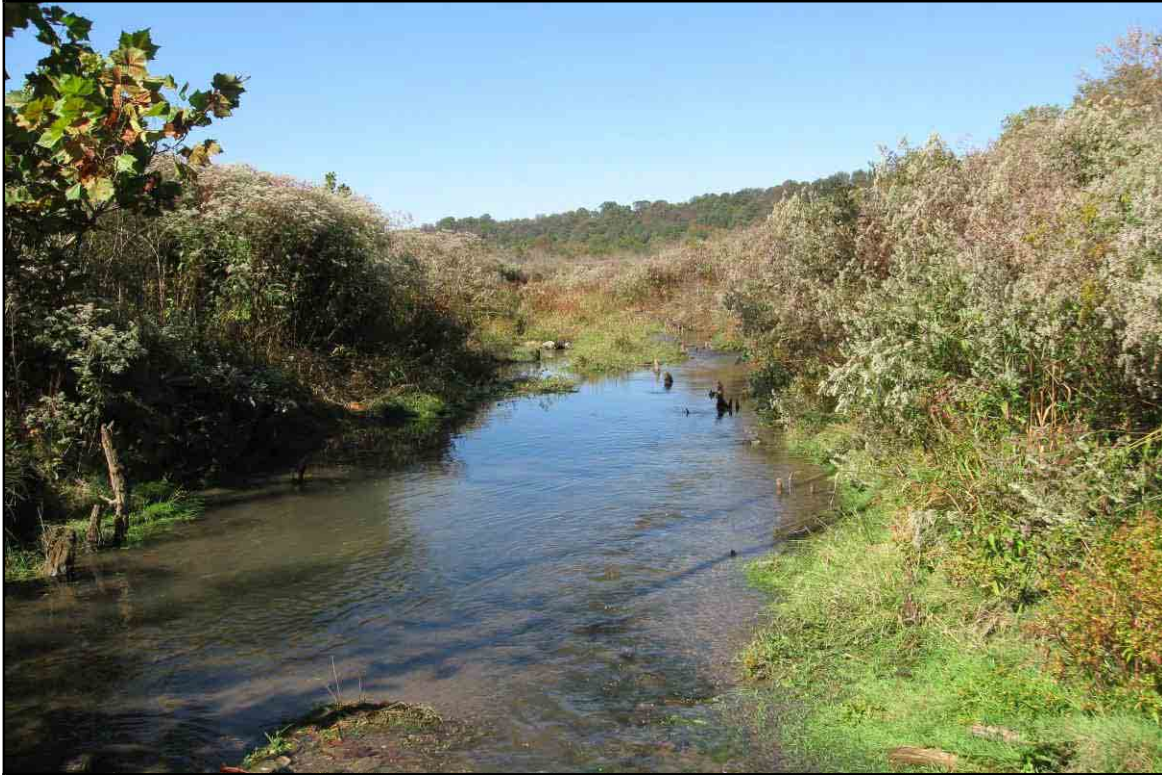
AS-3: Looking downstream (west; 2008).

AS-3 is located west of the main entrance to Cove Springs Park, just below where Penitentiary Branch flows under US 127. At the time of study, weather conditions were sunny and clear. Temperature was 82°F. During the previous 24 hours, there was no substantial rainfall. The surrounding landscape use is dominated by industry with some forested upland. The riparian zone was dominated by grasses and herbs, with a minor tree/shrub (*Fraxinus pennsylvanica*, *Platanus occidentalis*, and *Cephalanthus occidentalis*) component. The stream channel was 3-5 meters wide and ranged from 2 to 18 inches in depth. The reach length was approximately 100 m and possessed evidence of past channelization. The streams substrate was dominated by gravel in the riffles and gravel/silt in all other habitats.

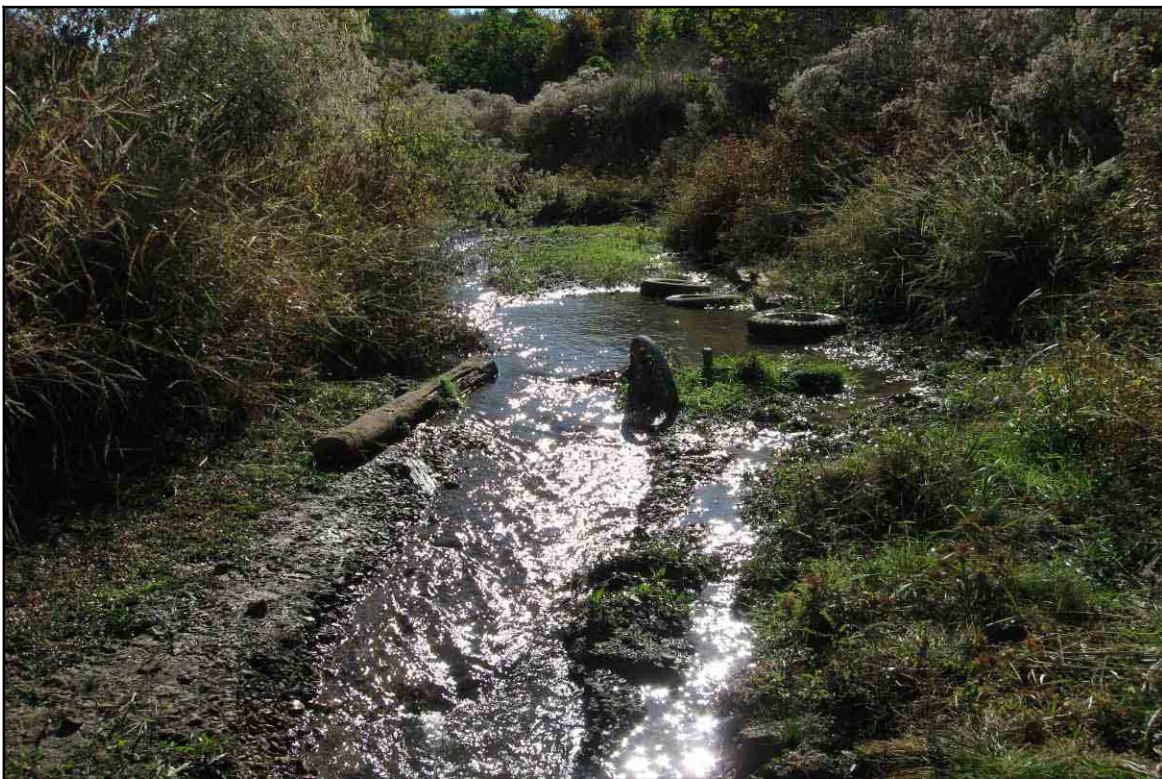
AS-3: Looking upstream (east; 2008).

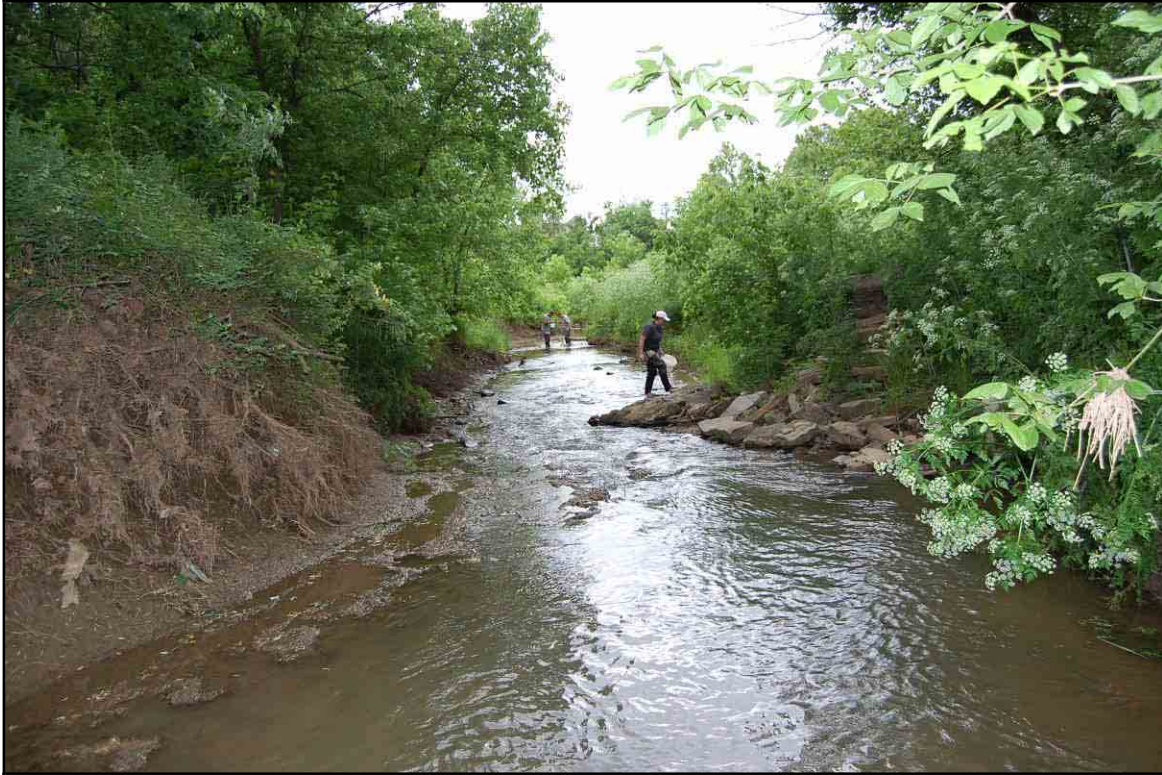
AS-4: Looking downstream (west; 2008).

AS-4 is located west of the main entrance to Cove Springs Park, just upstream from the flood control levee. At the time of study, weather conditions were sunny and clear. Temperature was 83°F. During the previous 24 hours, there was no substantial rainfall. The surrounding landscape use was industrial with some forested upland. The riparian zone was dominated by trees/shrubs (*Fraxinus pennsylvanica*, *Platanus occidentalis*, and *Cornus* spp) with a grass/herb component. The stream channel was 3-5 m wide and ranged from 2 to 18 inches in depth. The reach length was approximately 100 m and possessed some evidence of past channelization. Streambed substrate was dominated by gravel/cobble in the riffles and gravel/silt in all other habitats.

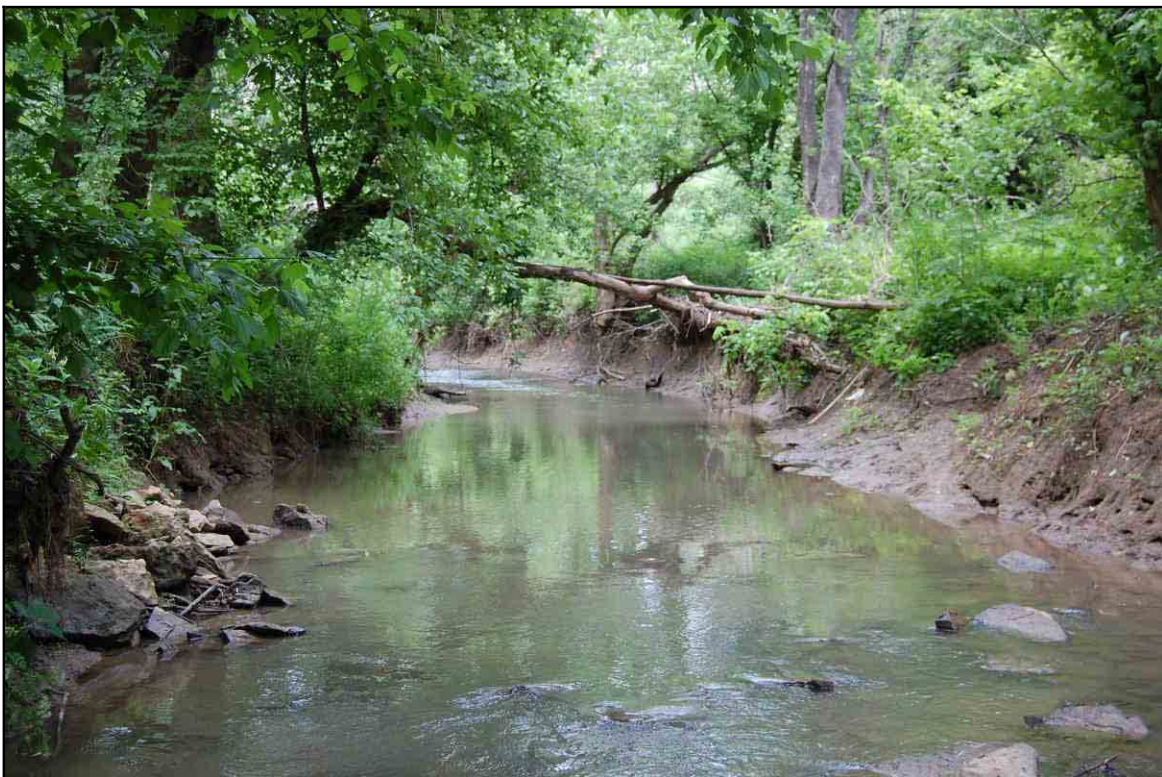
AS-4: Looking upstream (east; 2008).
